Pure Home Inspections  
(609) 820-1556  
NJ Home Inspector #24GI00155400

## Home Inspection Report

Address Inspected

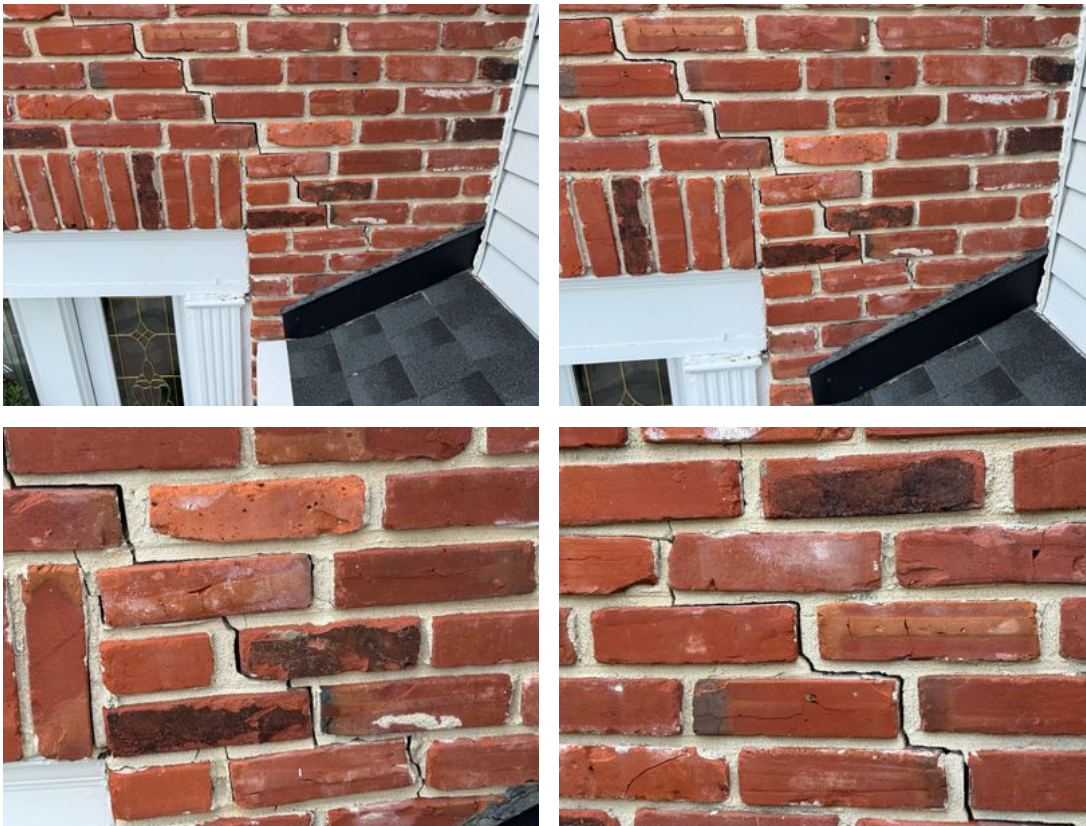
There were areas of the brick that have structural damaged and need to be repaired to prevent water intrusion and further deterioration. Recommend a qualified mason inspect and re-point the brick where needed.

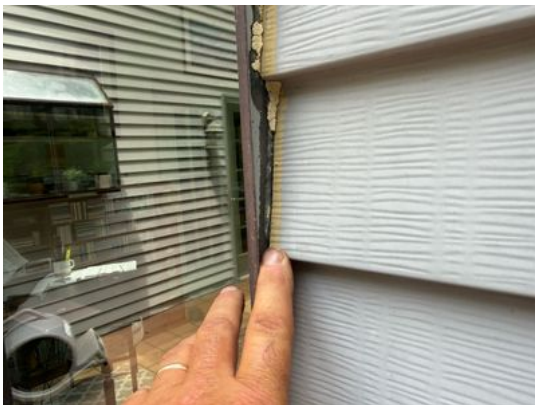
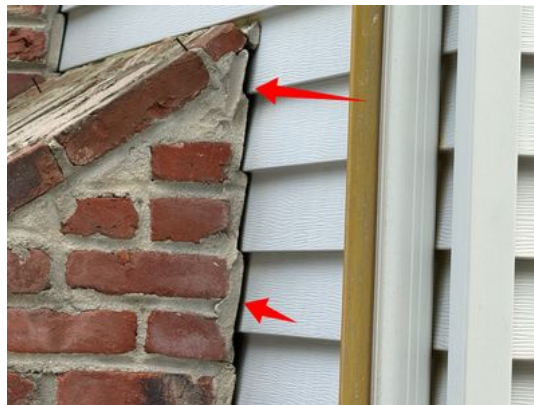
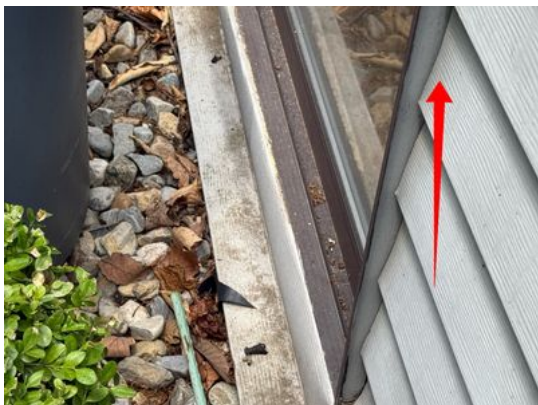
Some exterior caulk is cracking, deteriorated and missing. Seal and caulk around windows, doors, siding/masonry transitions and all siding penetrations to prevent water intrusion leading to wood rot and mold. As with all possible moisture intrusion areas hidden damage may be present.

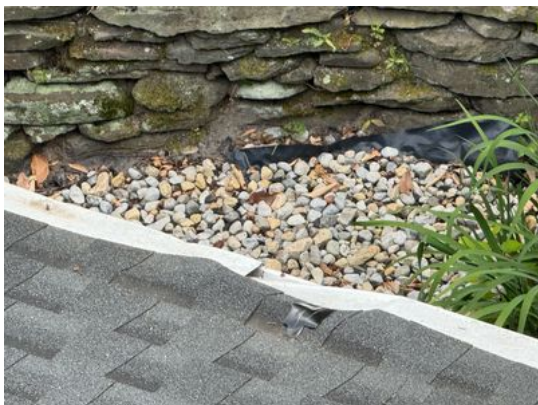
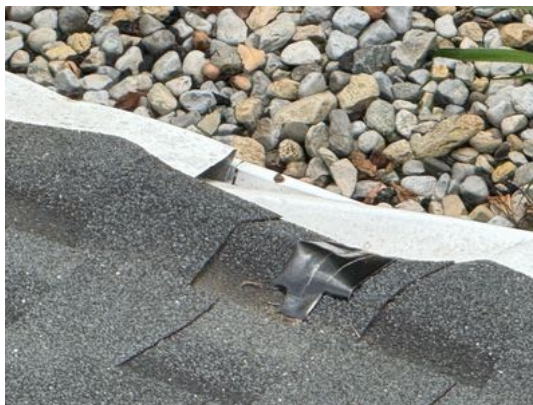
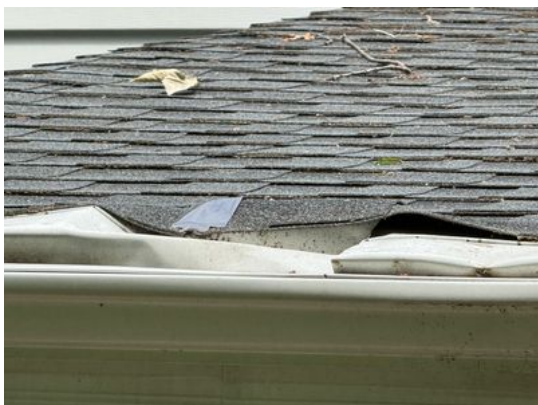
### Roofing: Roof Covering

At the time of the inspection the roof was in serviceable condition with repairs needed. There was damage to the rear roof over the sun room. This will need repairs to prevent moisture intrusion and damage.

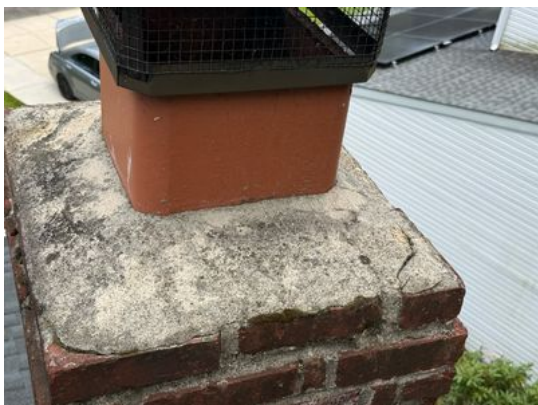
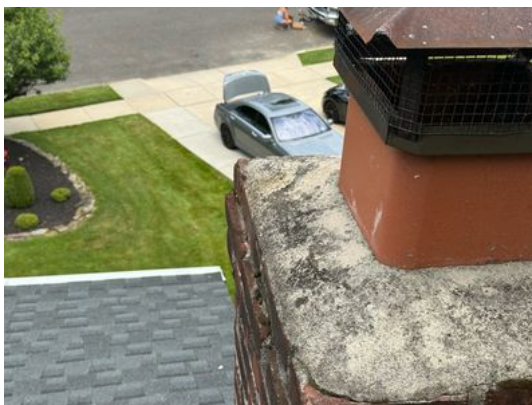
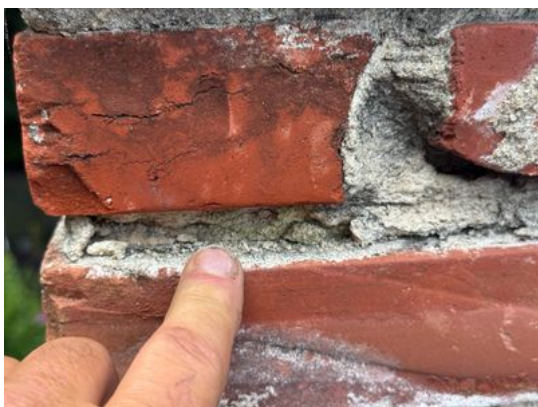
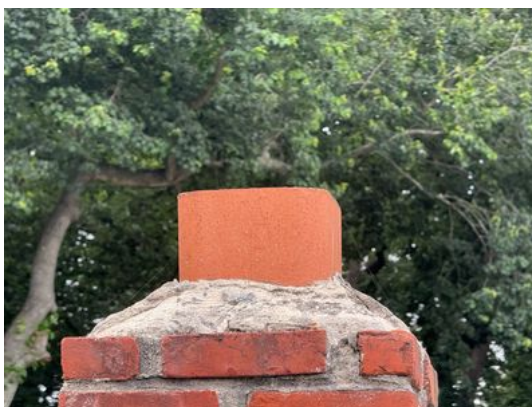
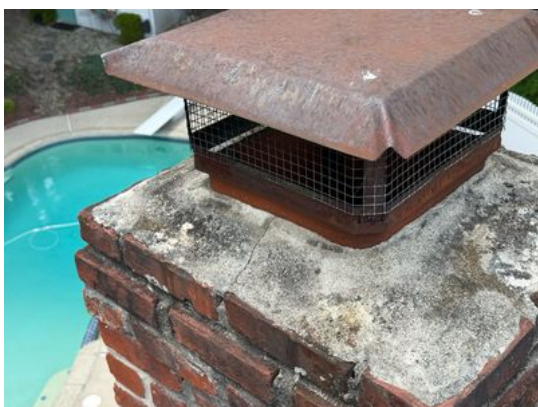
### Roofing: Chimney

The chimney's had evidence of deterioration to the chimney wash at the top and portions of the mortar joints. Have repairs and further evaluation performed by a qualified contractor to prevent moisture intrusion and further deterioration.

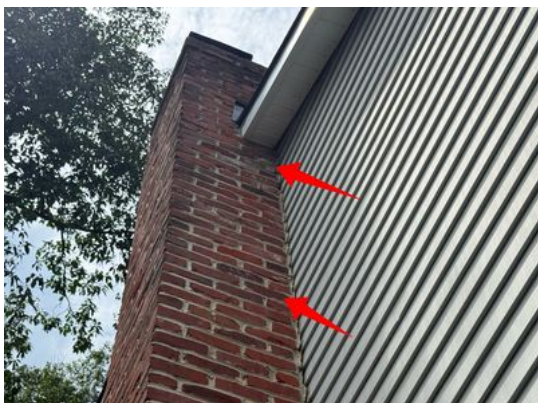
### Roofing: Chimney

The chimney's show signs of settlement and possible movement. It was leaning and is recommended that it be repair/evaluated by a qualified chimney contractor.

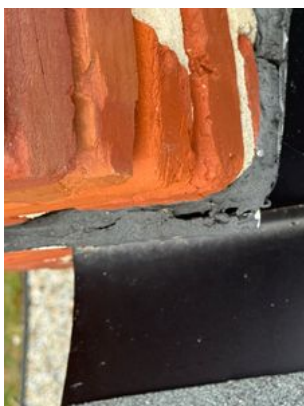
### Roofing: Flashings

The flashing and sealant around the chimney was deteriorated and in needed of repairs. There was evidence of water intrusion into the attic. Recommend repairs by a qualified roofing contractor to prevent water intrusion.

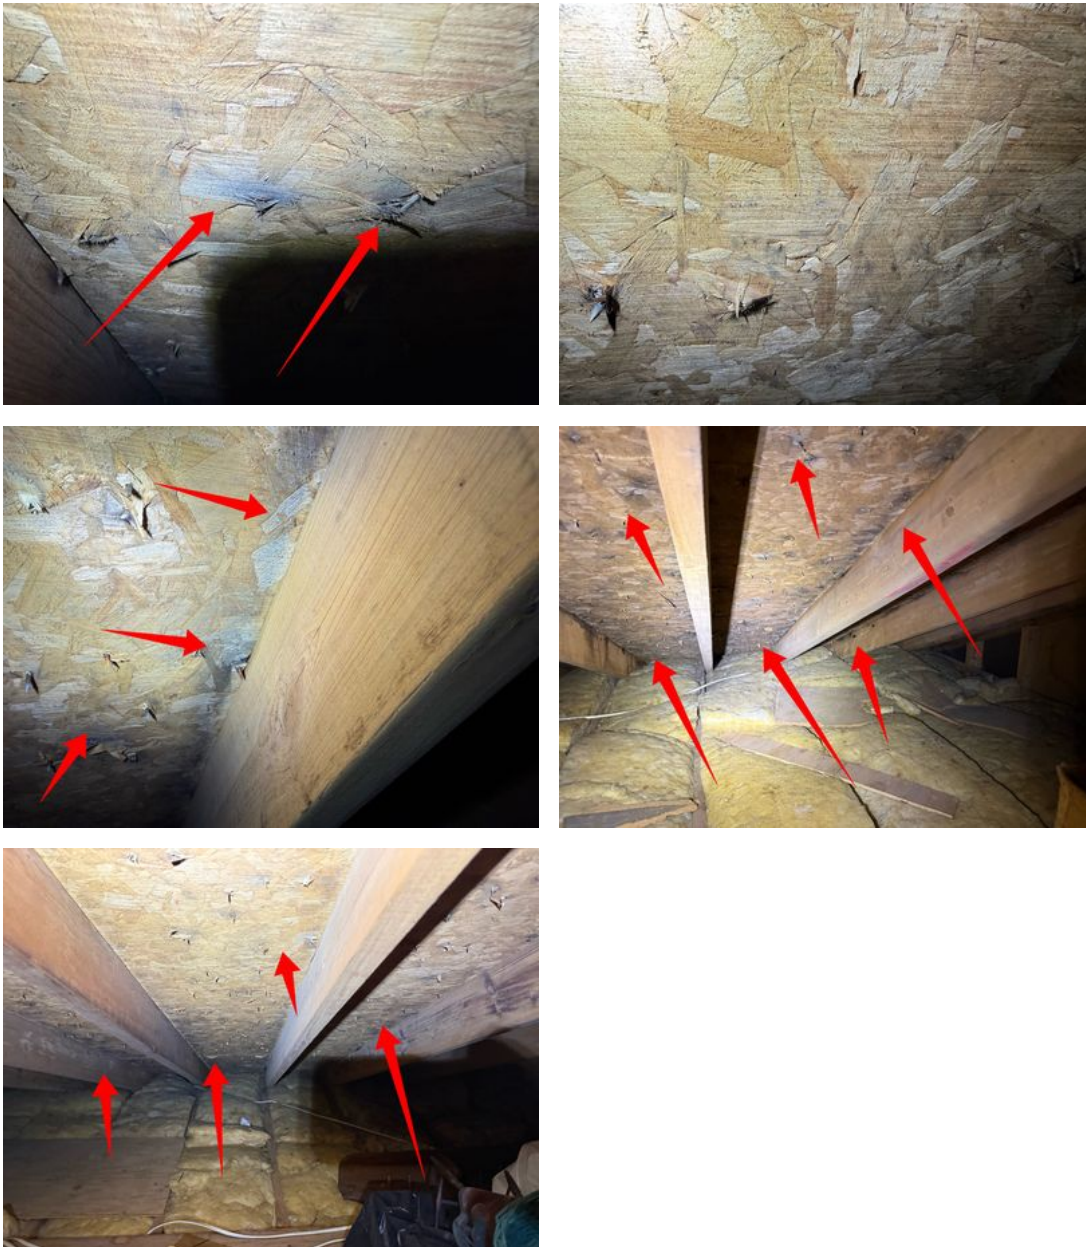
### Structure: Attic

The attic may not have a method of sufficient ventilation. Without proper attic ventilation wood rot and mold issues can become prevalent in the attic envelopes and even lead to structural issues that are concealed. Proper Hi/Low ventilation should be added to allow sufficient hi/low ventilation. Organic growth was observed on the under side of the roof sheathing in the attic. Mold testing is recommended to determine if mold growth is present

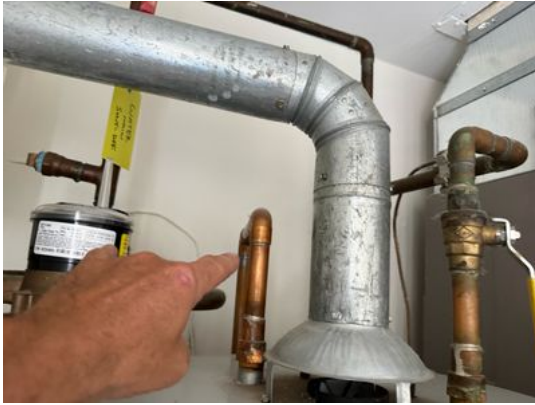
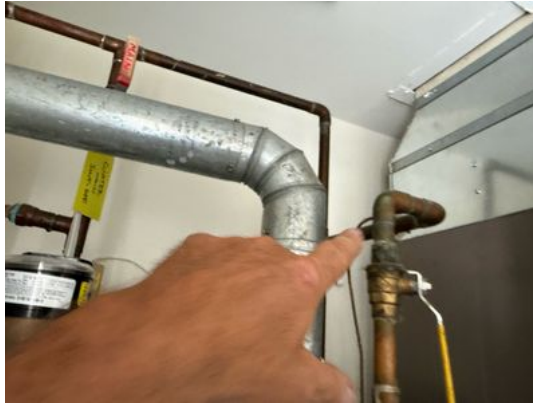
Modern building science requires a bonding wire jumper from the cold water pipe to the hot water pipe at the water heater. The bonding wire will protect the hot water heater in the event of an electrical surge. This is a potential safety hazard and requires repairs.

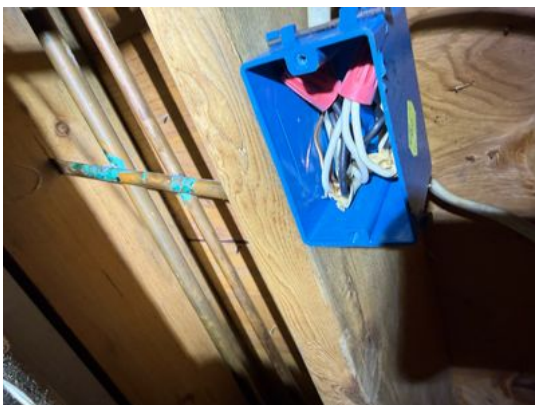
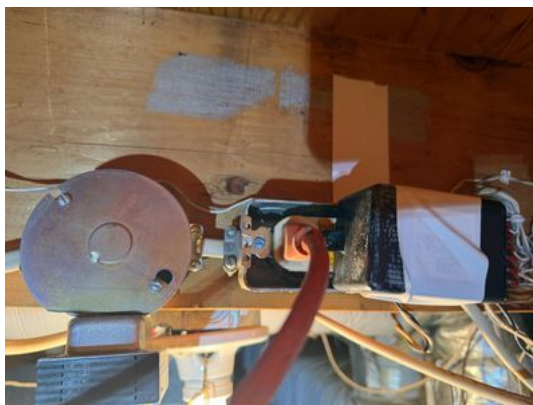
In the crawlspace there are missing/damaged junction box cover/fixture. Junction boxes without proper covers are a fire and safety concern. Replace/repair by a licensed electrician to prevent electrical shock.

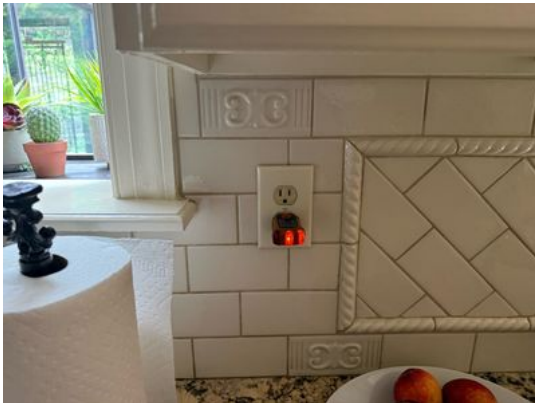
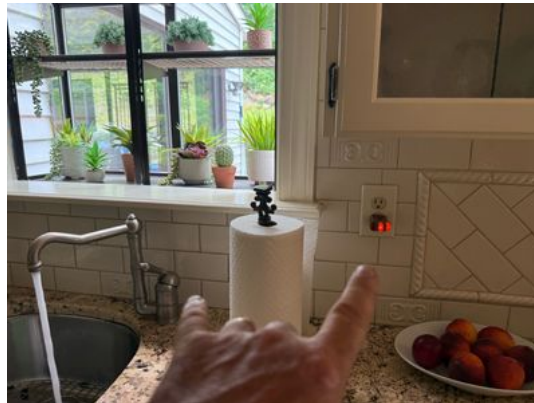
Any outlet within 6' of a water source is required to be a GFCI outlet to prevent electrical shock. Outlet within 6' of the kitchen sink were not GFCI outlets. Recommend replacement by a licensed electrician.

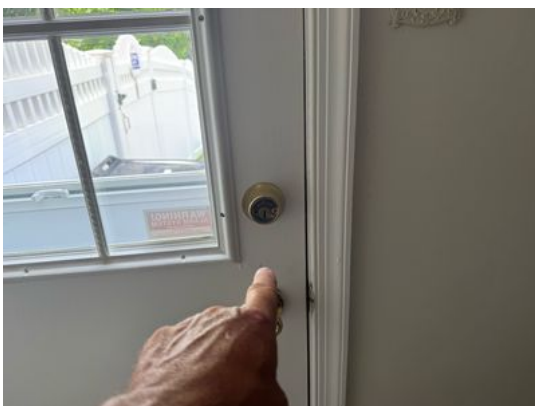
The front and rear exterior door has an unsafe dead bolt lock. Modern building sciences call for the use of a turn knob dead bolt where the interior lock is a turn knob and not a keyed interior. A keyed interior dead bolt could limit ability to exit in case of an emergency.

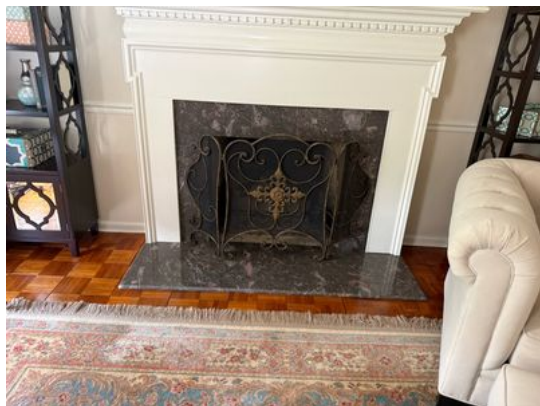
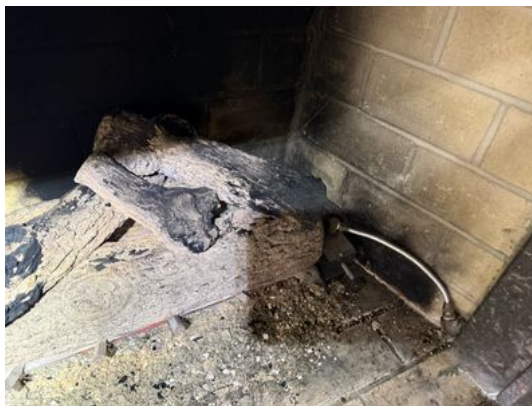
### Interior: Fireplace

The controls for the living room gas fire place did not function at the time of the inspection. Therefore the unit was not tested and is excluded from the inspection. Recommend service and testing the operation of the fireplace prior to settlement.

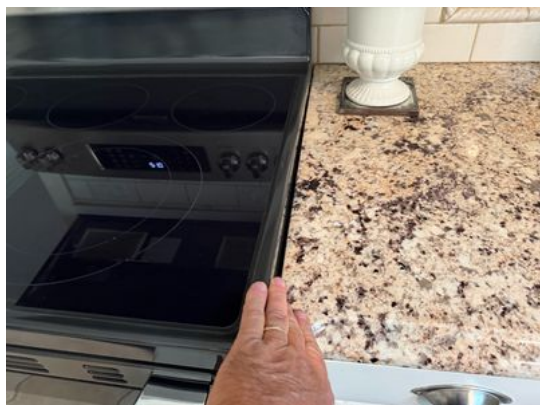
### **Kitchen: Appliances: Range**

The stove did not have an anti tip bracket installed. Recommend addition of anti tip bracket to prevent stove from tipping forward and spilling scolding fluids on someone.

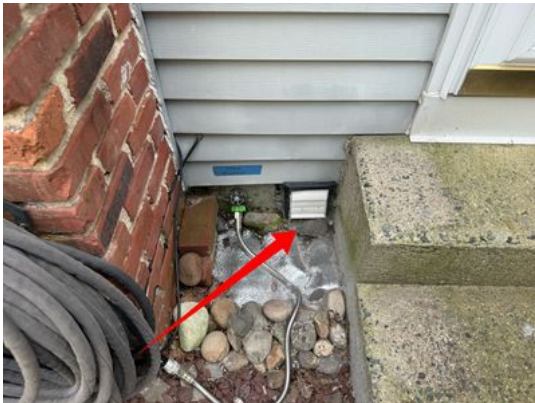
### **Laundry: Dryer Venting**

The dryer venting was in poor condition/damaged. Recommend replacement and venting at least 12" above ground level to allow proper venting in the event of snow fall.

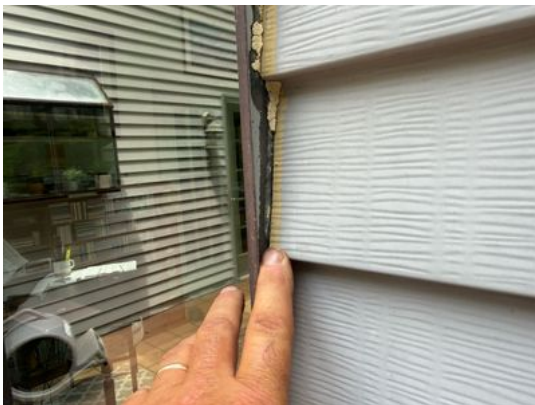
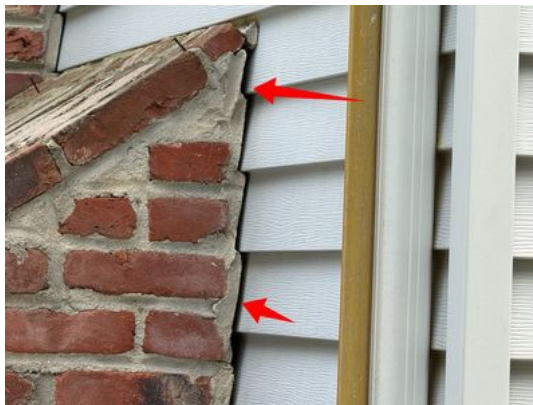
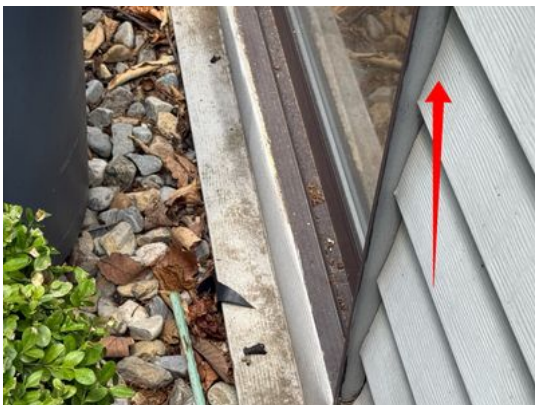
Some exterior caulk is cracking, deteriorated and missing. Seal and caulk around windows, doors, siding/masonry transitions and all siding penetrations to prevent water intrusion leading to wood rot and mold. As with all possible moisture intrusion areas hidden damage may be present.

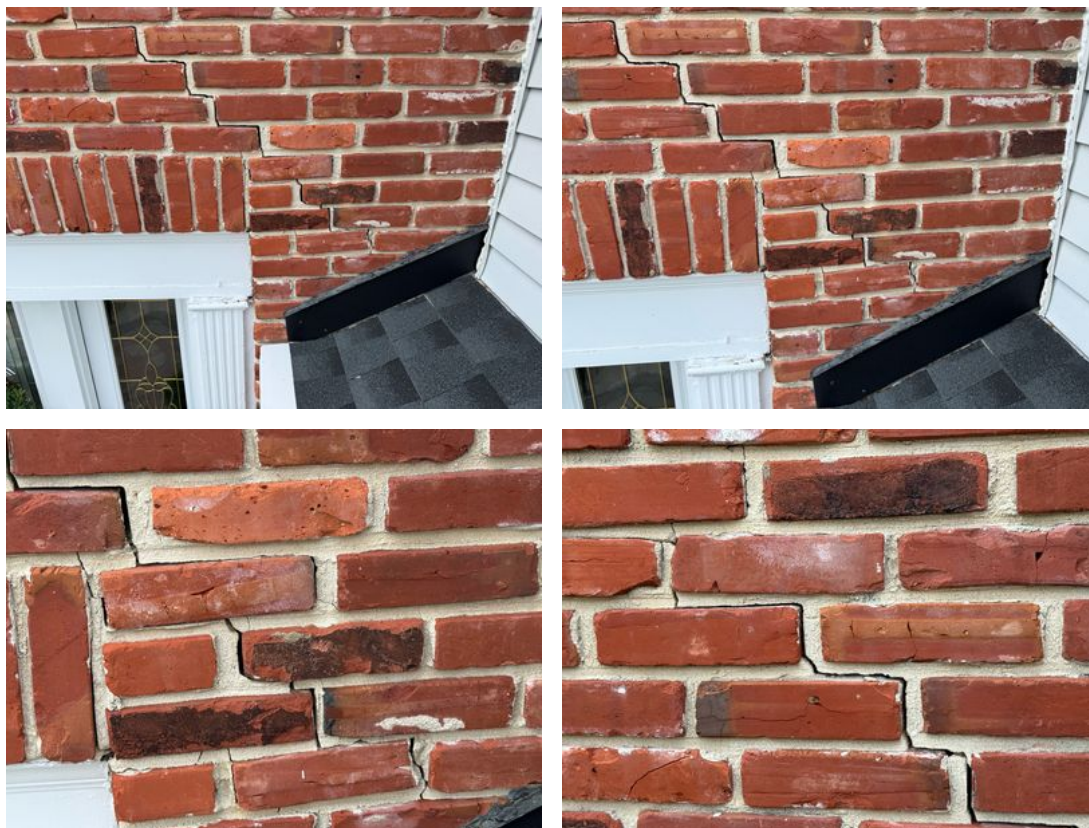
#### Comment 7

There were areas of the brick that have structural damaged and need to be repaired to prevent water intrusion and further deterioration. Recommend a qualified mason inspect and re-point the brick where needed.

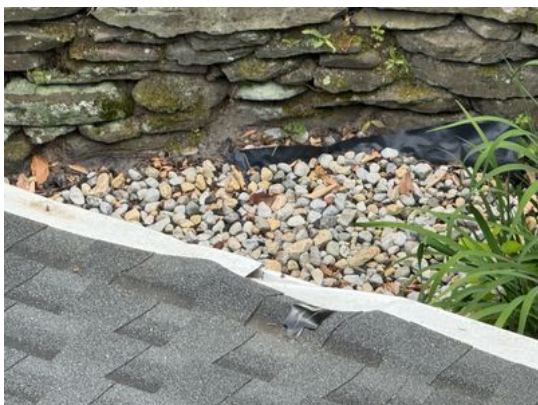
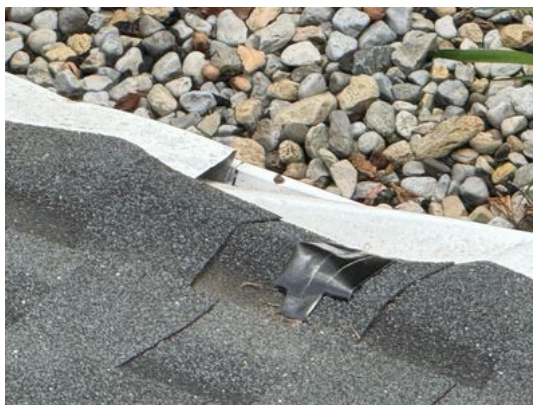
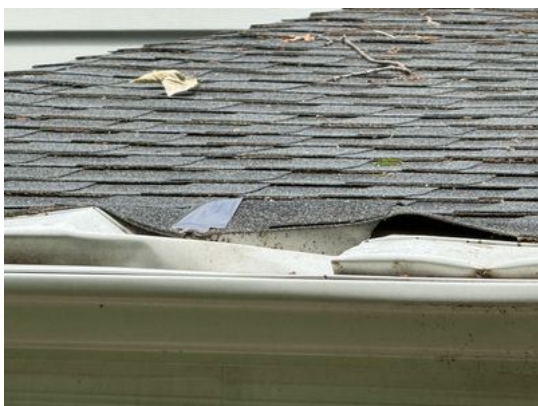
At the time of the inspection the roof was in serviceable condition with repairs needed. There was damage to the rear roof over the sun room. This will need repairs to prevent moisture intrusion and damage.

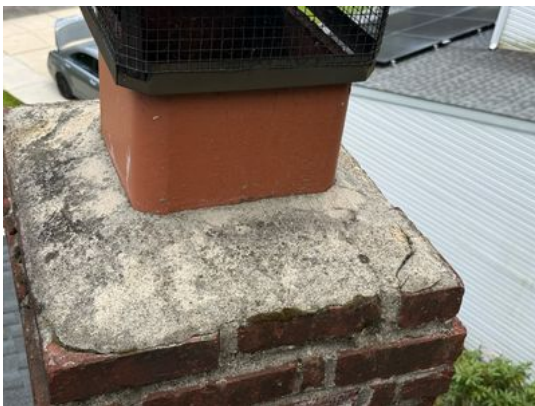
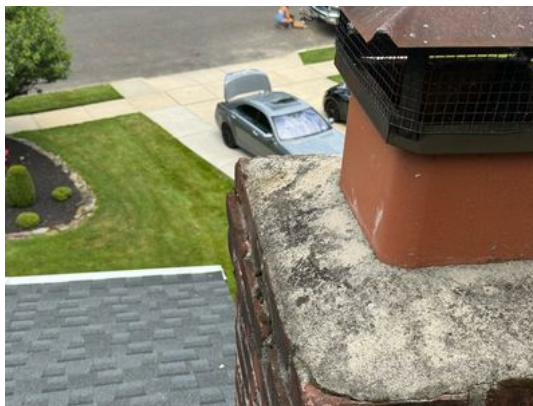
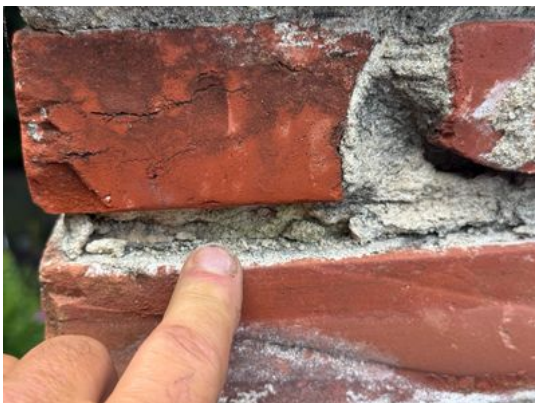
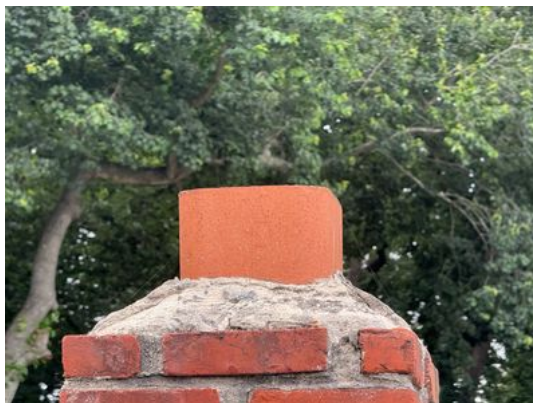
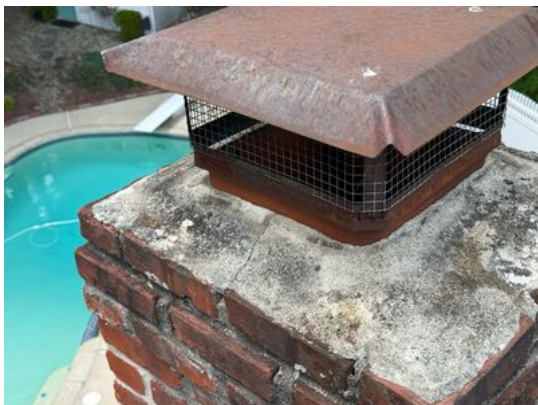
The chimney's had evidence of deterioration to the chimney wash at the top and portions of the mortar joints. Have repairs and further evaluation performed by a qualified contractor to prevent moisture intrusion and further deterioration.

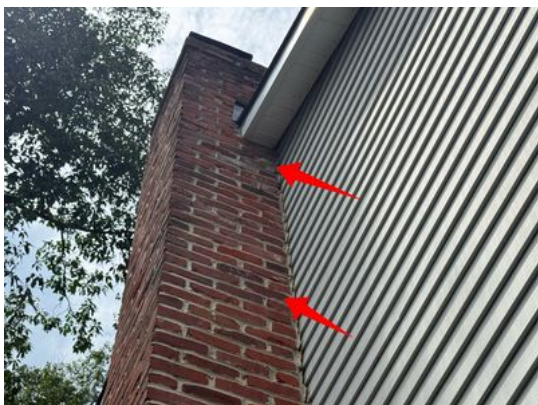
**Comment 10**

The chimney's show signs of settlement and possible movement. It was leaning and is recommended that it be repair/evaluated by a qualified chimney contractor.

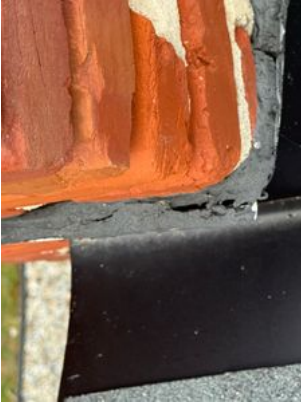
The flashing and sealant around the chimney was deteriorated and in needed of repairs. There was evidence of water intrusion into the attic. Recommend repairs by a qualified roofing contractor to prevent water intrusion.

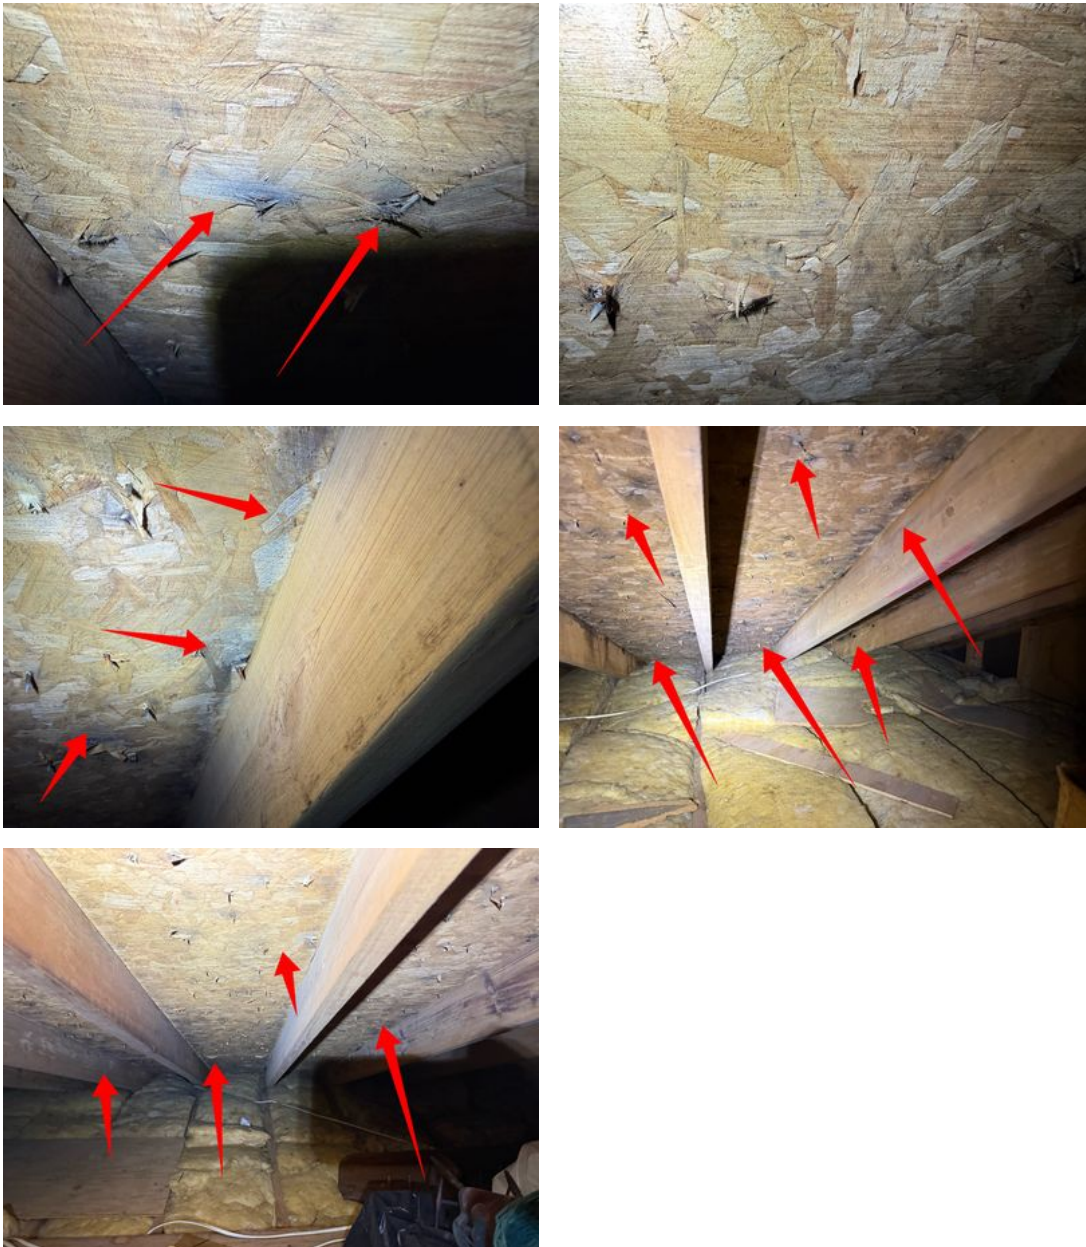
The attic may not have a method of sufficient ventilation. Without proper attic ventilation wood rot and mold issues can become prevalent in the attic envelopes and even lead to structural issues that are concealed. Proper Hi/Low ventilation should be added to allow sufficient hi/low ventilation. Organic growth was observed on the under side of the roof sheathing in the attic. Mold testing is recommended to determine if mold growth is present

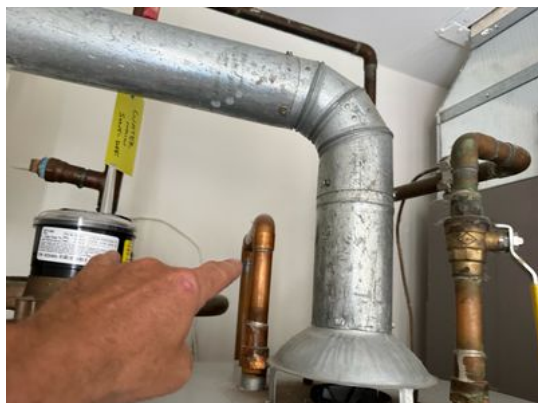
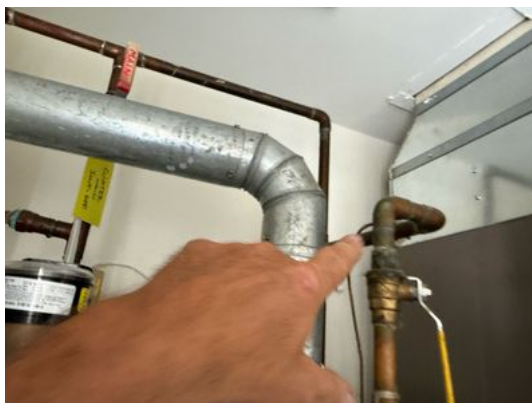
#### Comment 14

Modern building science requires a bonding wire jumper from the cold water pipe to the hot water pipe at the water heater. The bonding wire will protect the hot water heater in the event of an electrical surge. This is a potential safety hazard and requires repairs.

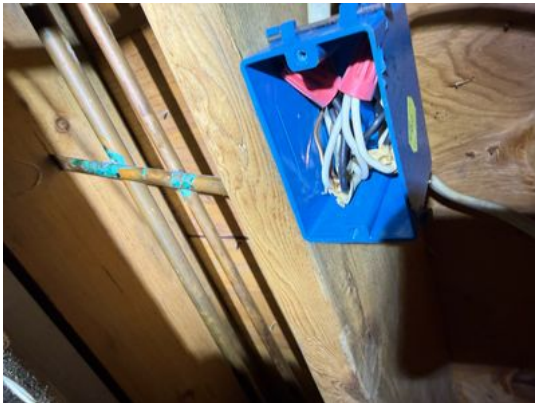
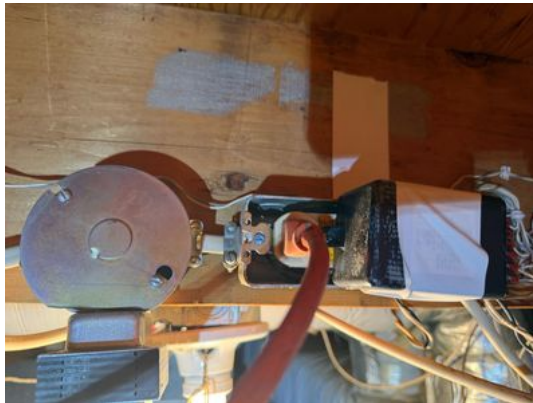
In the crawlspace there are missing/damaged junction box cover/fixture. Junction boxes without proper covers are a fire and safety concern. Replace/repair by a licensed electrician to prevent electrical shock.

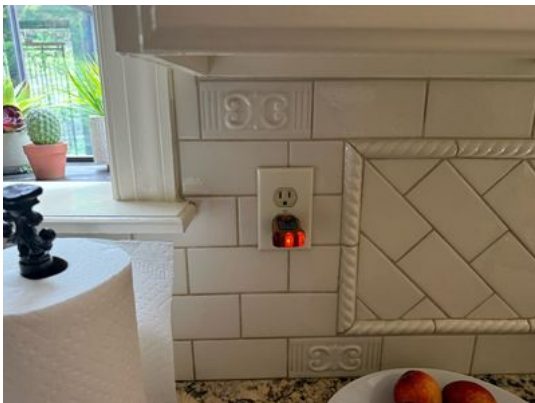
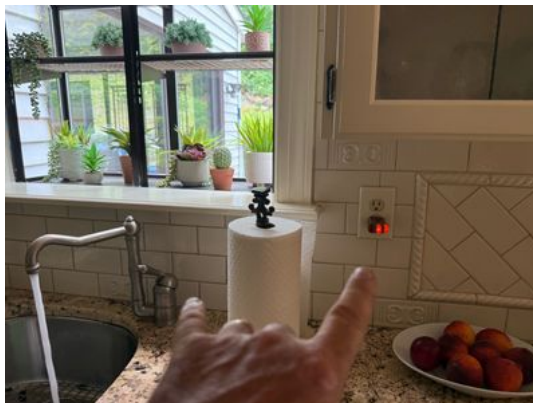
### Comment 17

Any outlet within 6' of a water source is required to be a GFCI outlet to prevent electrical shock. Outlet within 6' of the kitchen sink were not GFCI outlets. Recommend replacement by a licensed electrician.

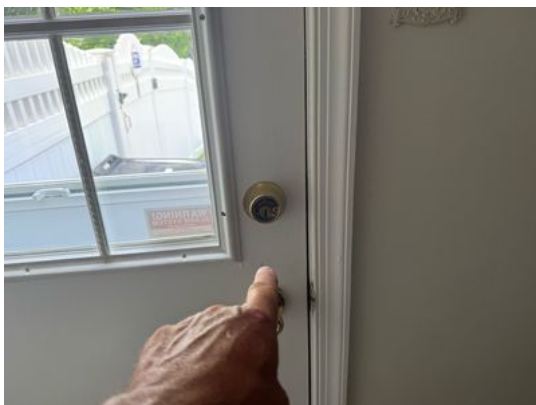
The front and rear exterior door has an unsafe dead bolt lock. Modern building sciences call for the use of a turn knob dead bolt where the interior lock is a turn knob and not a keyed interior. A keyed interior dead bolt could limit ability to exit in case of an emergency.

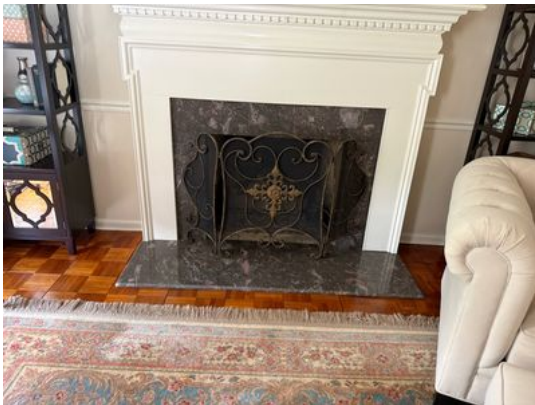
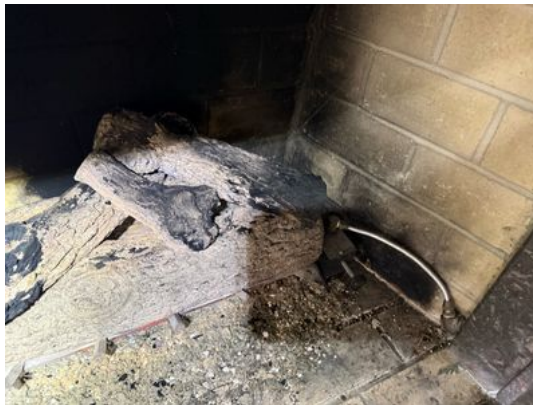
The controls for the living room gas fire place did not function at the time of the inspection. Therefore the unit was not tested and is excluded from the inspection. Recommend service and testing the operation of the fireplace prior to settlement.

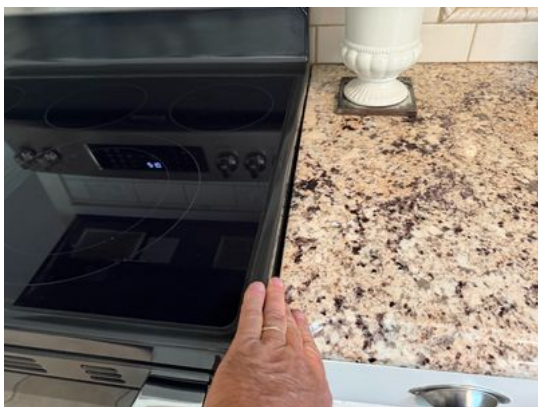
The stove did not have an anti tip bracket installed. Recommend addition of anti tip bracket to prevent stove from tipping forward and spilling scolding fluids on someone.

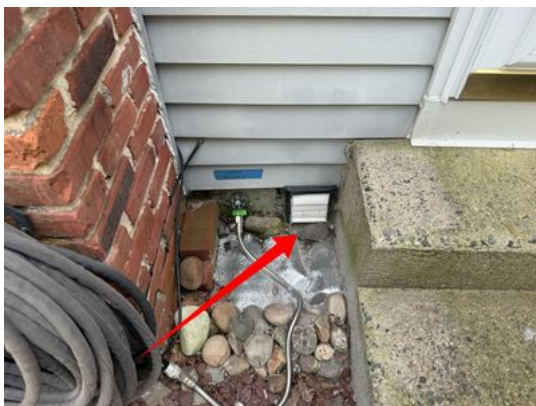
The dryer venting was in poor condition/damaged. Recommend replacement and venting at least 12" above ground level to allow proper venting in the event of snow fall.
